St Patrick's Church, Glenarm, Co. Antrim

In 2005 members of the NAC staff undertook a voluntary excavation at the Church of Ireland (background photograph) in Glenarm, Co. Antrim.

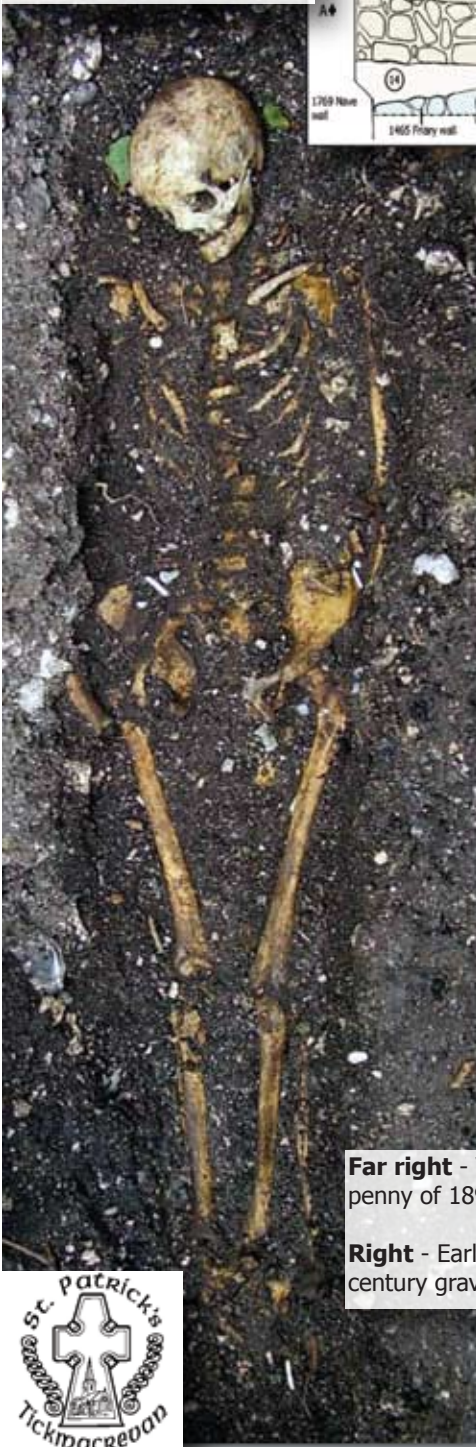
Right - Section showing the chancel wall over the friary.

The remains of a 15th century Franciscan friary lay to the rear of the church. The investigation showed that the chancel wall of the church was built directly on top of the earlier wall of the 1465 Friary.

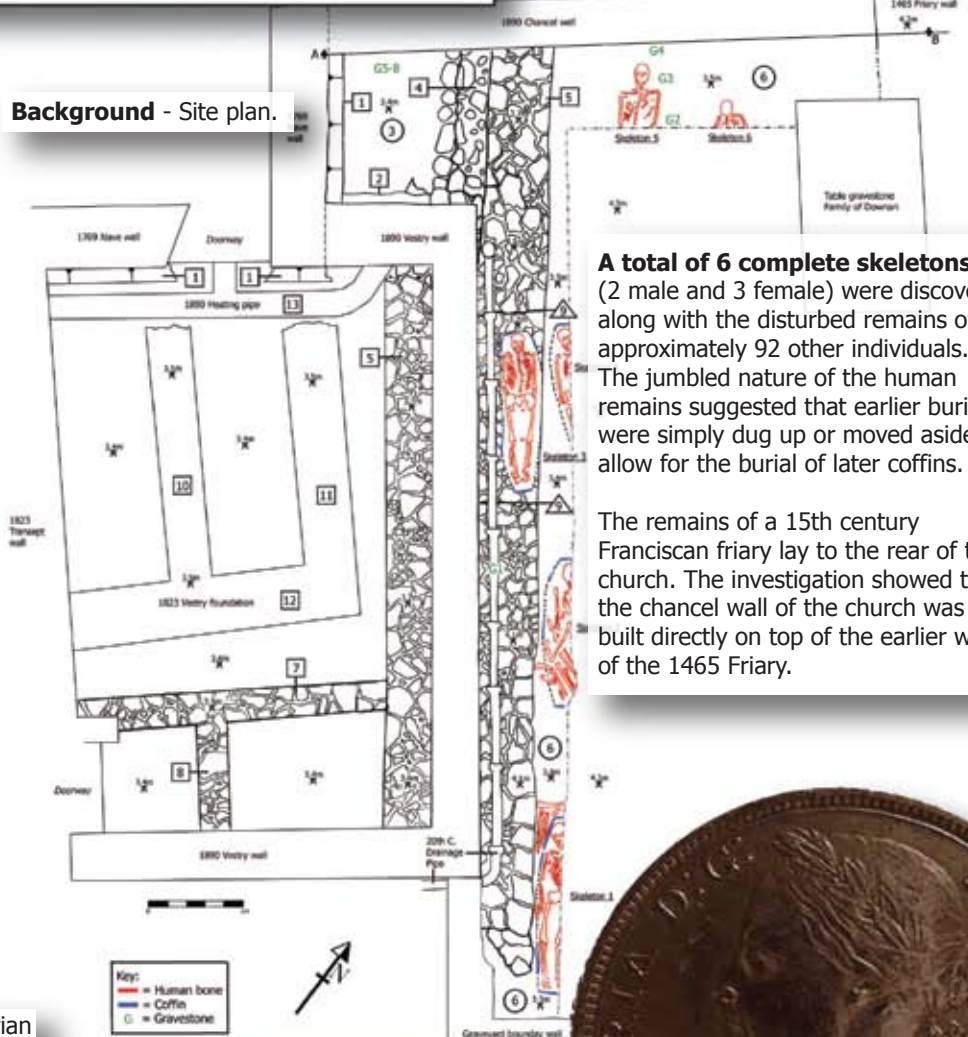
Background - Site plan.

This was done in order to facilitate restoration works that were being carried out at the church. The excavation consisted of a drainage trench to the rear of the vestry and along the eastern wall of the chancel.
